Natural Flood Management

Protecting Communities through Peatland Restoration in Cumbria

Cumbria
Wildlife Trust

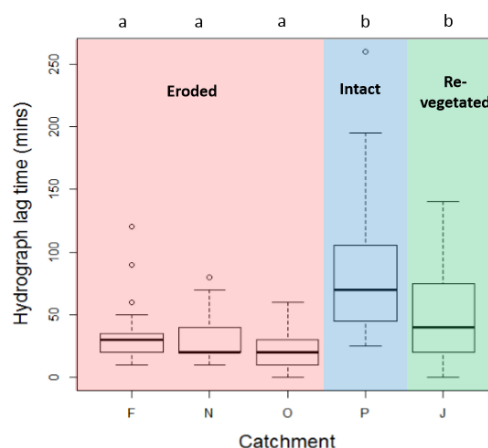
MS4W Peak District catchments:
Comparison of stormflow lag times in the
space-for-time study (2010-11 data)

1. Peat restoration in upland blanket peat systems reduces storm flow in headwaters and can contribute to the reduction of downstream flood risk
2. Restoration of bare and gullied peat significantly alters storm flow release from headwater micro-catchments, reducing peak flows by 30% and increasing lag times by c.20 minutes
3. Model upscaling suggests that re-vegetation across 12% of a 9 km² catchment would reduce flood peaks of severe storms by upto 5% and, with additional gully blocking, by upto 8%
